ADVANCED GAS TURBINE (AGT) TECHNOLOGY DEVELOPMENT

NINTH SEMIANNUAL PROGRESS REPORT (JANUARY 1984 — JUNE 1984)

Engineering Staff of Garrett Turbine Engine Company A Division of The Garrett Corporation

DECEMBER 1984

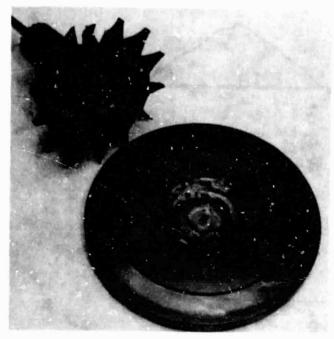
- o A heavy turbine wheel rub with the ceramic turbine backshroud was incurred (See Figure 30).
- o Metal "shavings" from the turbine rotor backface were deposited on the ceramic turbine backshroud (Figure 31)
- The ceramic turbine shroud was radially rubbed by the metallic turbine rotor; no significant damage was evident (Figure 32)
- A ceramic combustor baffle support leg was the only ceramic part found chipped (Figure 33)

Figure 30. Turbine Rotor/Backshroud Rub.

The primary cause of failure was insufficient turbine backface rotor-to-turbine backshroud clearance. Dimensions on the turbine backshroud were rechecked against the Build 3 backshroud, and a local contour discrepancy was bound.

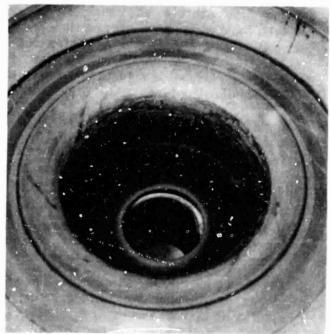
Figure 32. Turbine Shroud Shows Radial Rub from Turbine Rotor.
